# **Coastal Processes and Beach Erosion: The Saco Bay Shoreline**

by  
Peter Slovinsky, Coastal Geologist  
Maine Geological Survey  
2005

This slideshow provides information on coastal morphology and coastal processes in Maine, with a focus on Saco Bay, home of the longest stretch of sandy shoreline within the state, and Camp Ellis, home of some of the worst erosion in the state.

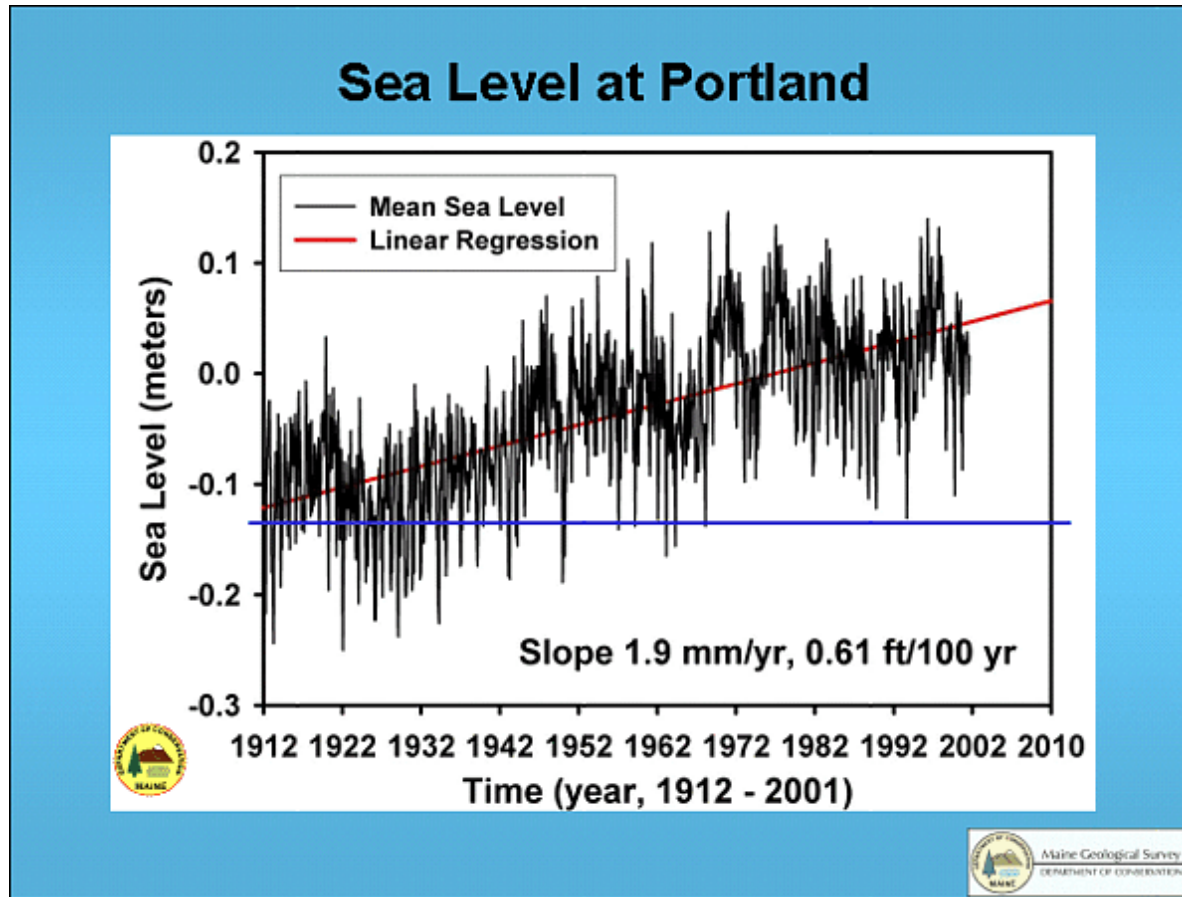
Sea-level Change at Portland

This graph shows sea level changes at the Portland tide gauge. Sea level has risen about 0.6 feet over the past 100 years.

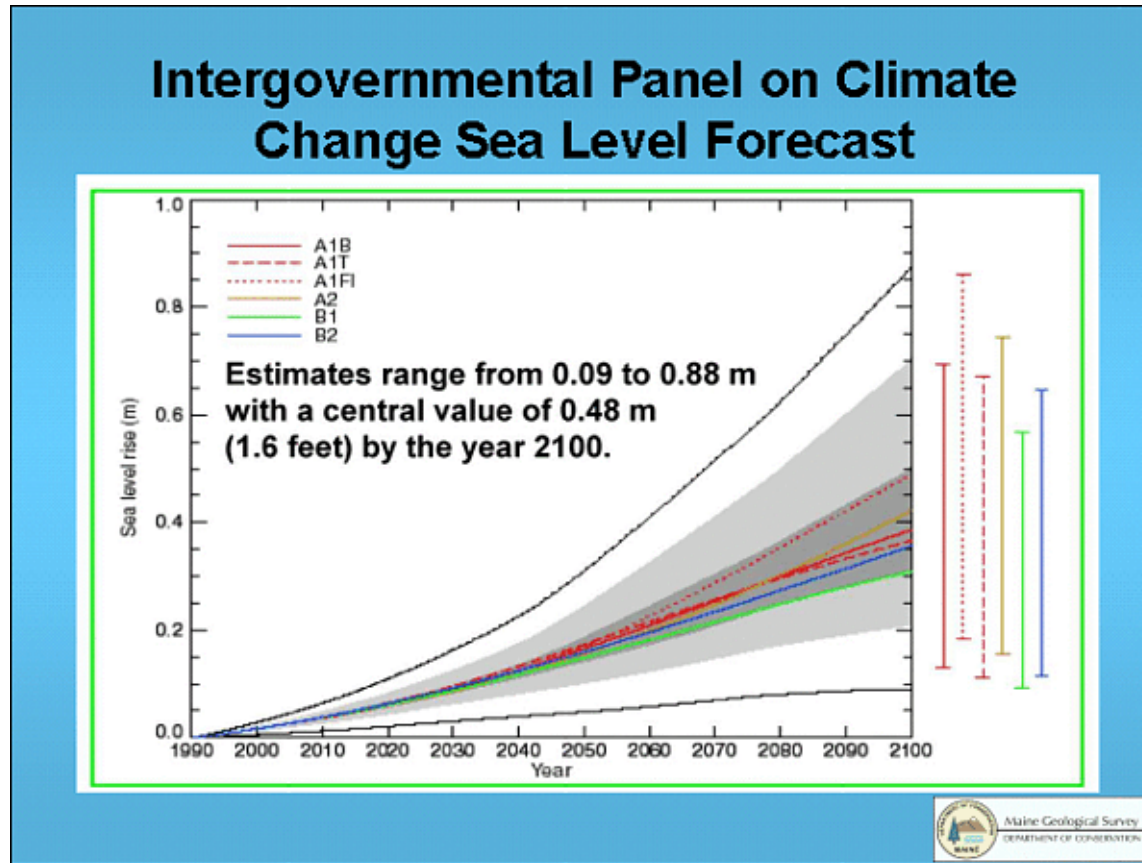
Sea-level Forecast

The Intergovernmental Panel on Climate Change (IPCC) used several different models to predict sea level rise in the next 100 years. The central value of these predictions is about 1.6 feet by the year 2100.

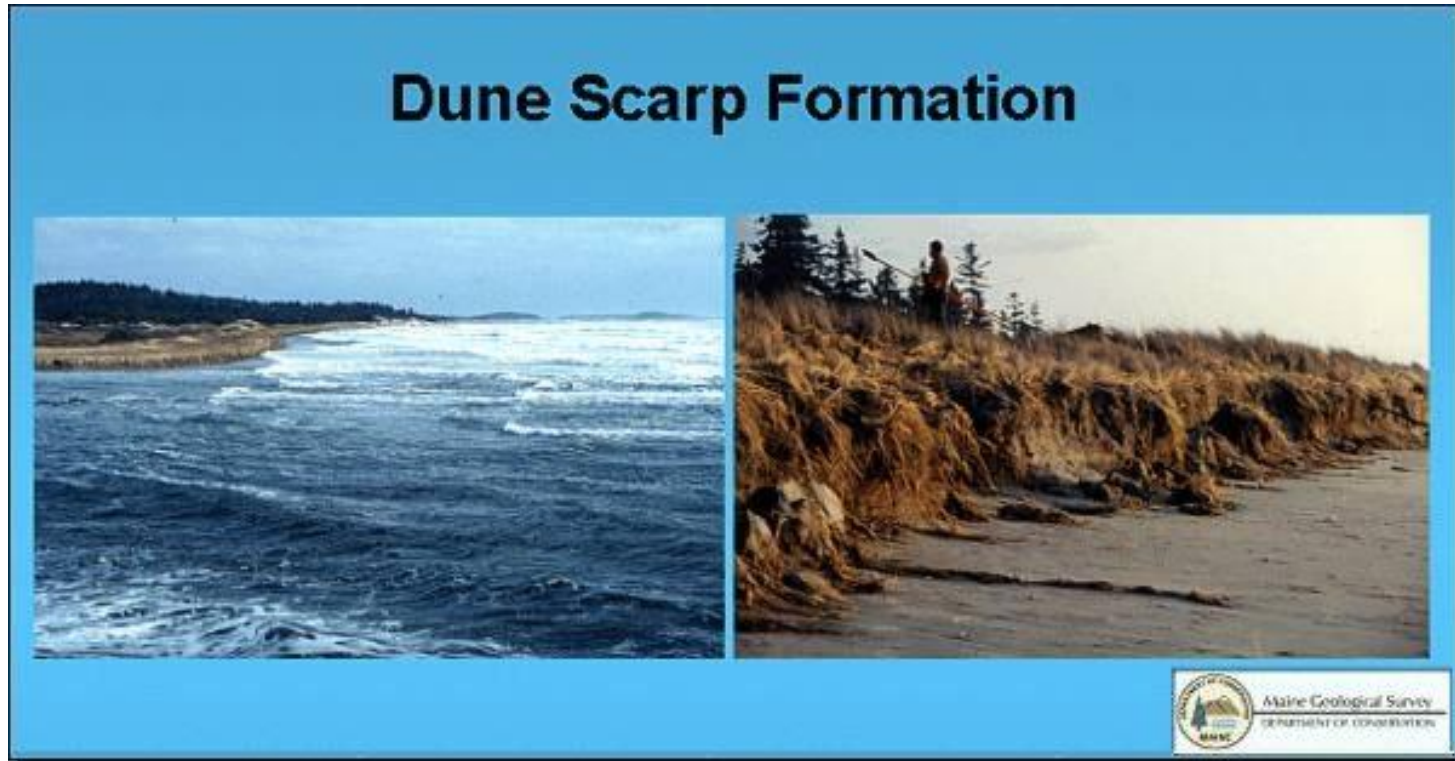
Dune Scarp Formation

A four-day northeaster in December 1992 resulted in a coastal storm surge (left) of less than 2 feet yet it produced an erosional cut in the dunes at Seawall Beach, Phippsburg. Northeasters commonly produce frontal dune erosion and scarp formation (right). Note the person in the picture on the right for scale. Dune scarps from major storms can take years to return to the pre-storm condition.

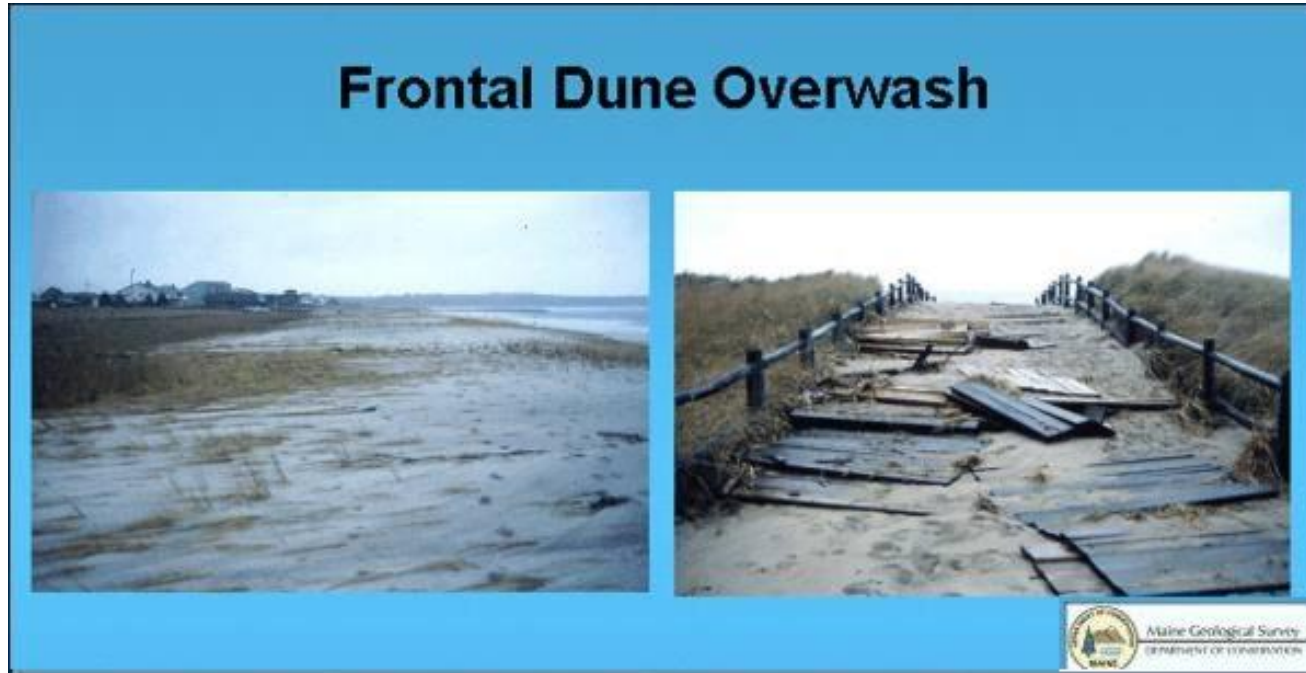
Frontal Dune Overwash

Examples of frontal dune overwash resulting from the Halloween 1991 "Perfect" Storm. The frontal dune ridge is built primarily from wave action. In storms, waves deposit sand on the crest of the dune ridge. Most frontal dune ridges are built by the process of overwash to the elevation of active wave run-up and sand transport in a 100-year storm. Lesser storms add sand to low dune areas where wind and foot traffic have lowered the ground elevation. American beach grass grows through the new sand and helps hold it in place. MGS File Photos of Pine Point in Scarborough (left) and Ferry Beach State Park, Saco (right).

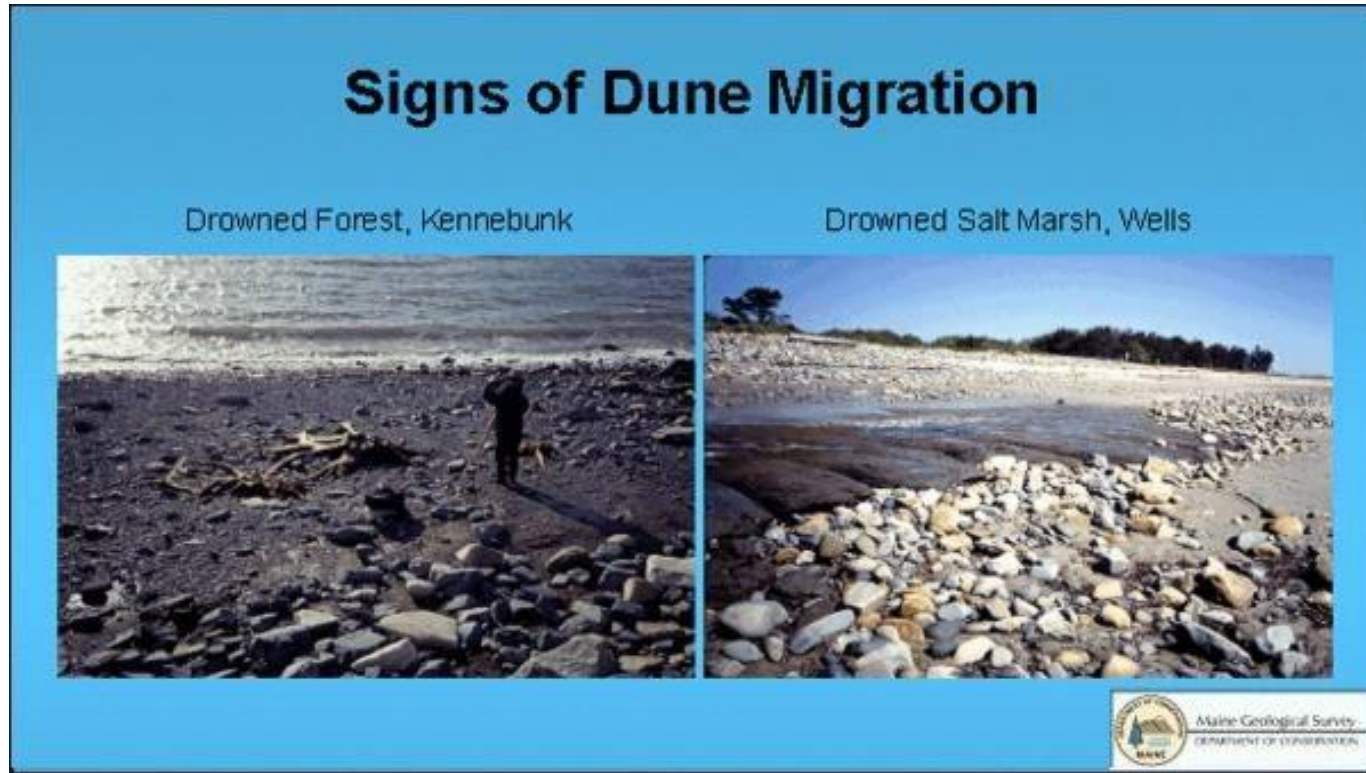
Dune Migration

Evidence of sea-level rise and beach and dune transgression (retreat). Tree stumps (in situ) on a beach in Kennebunk were drowned by the rising sea (left). Salt marsh peat from the back barrier marsh is exposed on Laudholm Beach in Wells (right). In both locations, the barrier beach and dunes have migrated inland over forest and marsh environments due to sea-level rise of about 6 feet in the last 3,000 years.

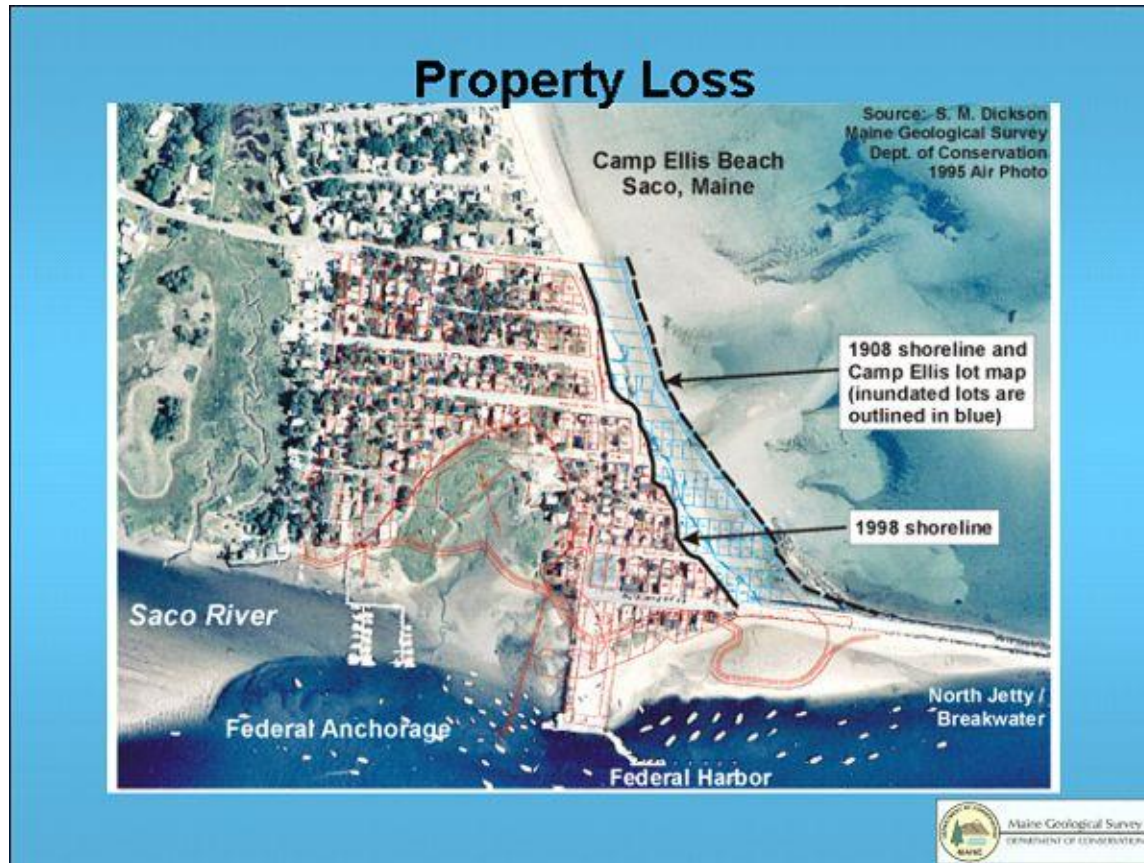
Property Loss at Camp Ellis

This slide shows historic loss of property in Camp Ellis. The 1908 shoreline (dashed line) is shown along with a 1908 tax map. The 1998 shoreline (solid line) is shown, with all tax lots currently underwater shown in blue. 36 developed lots have been lost in less than 100 years.

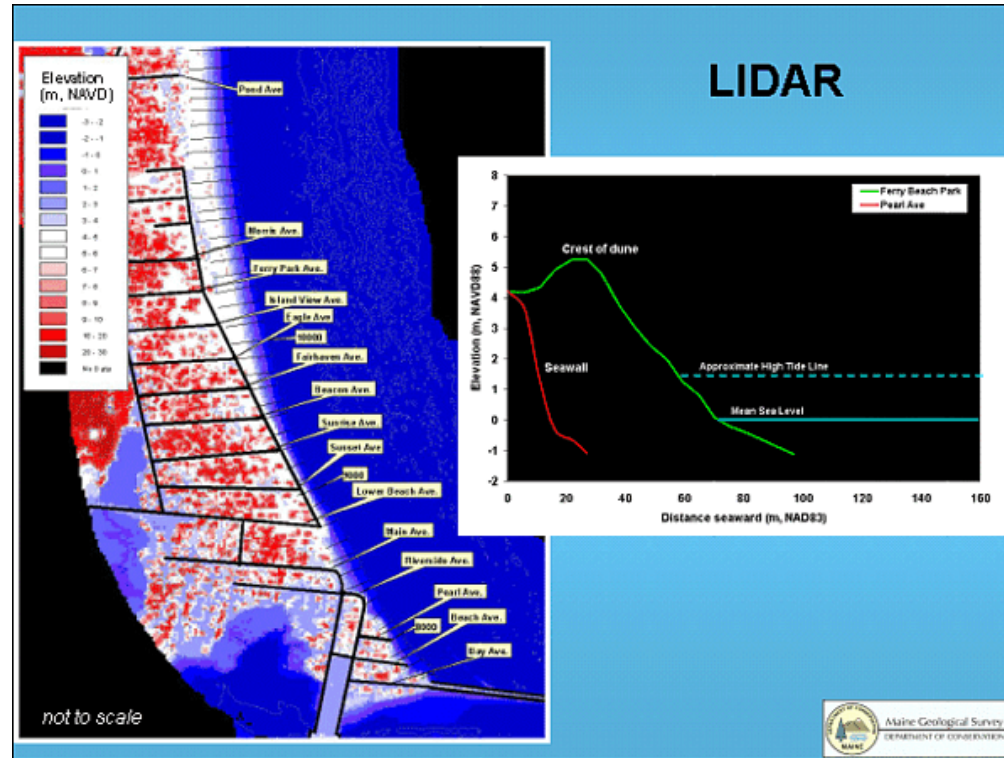
## Camp Ellis LiDAR

Light Detection and Ranging (LIDAR) data was used to create this image showing topography along Camp Ellis Beach. Beach profiles from Ferry Beach Park (north of Pond Avenue) and Pearl Avenue (near jetty) show the differences in topography of the beaches. At Pearl Avenue, a large, steep seawall protects properties immediately adjacent to the shoreline. In comparison, the natural profile at Ferry Beach Park shows a well developed dune, and much more gradual slope.

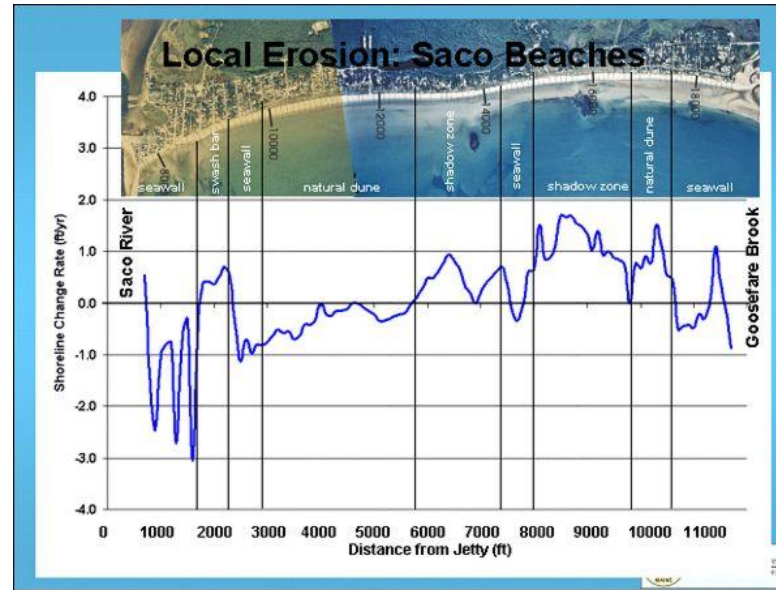
Shoreline Stabilization

This slide shows the influence of shoreline stabilization (jetties and seawalls) and underlying geology on shoreline change (1962-1995) along the stretch of beach from Camp Ellis to Goosefare Brook (left-right). Closest to the jetty, the beach is heavily seawalled and is highly erosive. A small section of unstabilized shoreline, where a swash bar attaches to shore, has a slight accretive trend, which reverts back to an erosive trend along shoreline fronted by large seawalls. Downdrift from this (right) is a large stretch of natural beach within which a nodal point occurs - that is the trend switches from dominantly erosive to dominantly accretive. This occurs about 6,000 ft north of the jetty, and is visible as a small bulge in the shoreline. This is due to a shadow zone created by a large rock outcrop in the surf zone. An additional shadow zone, also created by an outcrop, is visible farther down the beach.

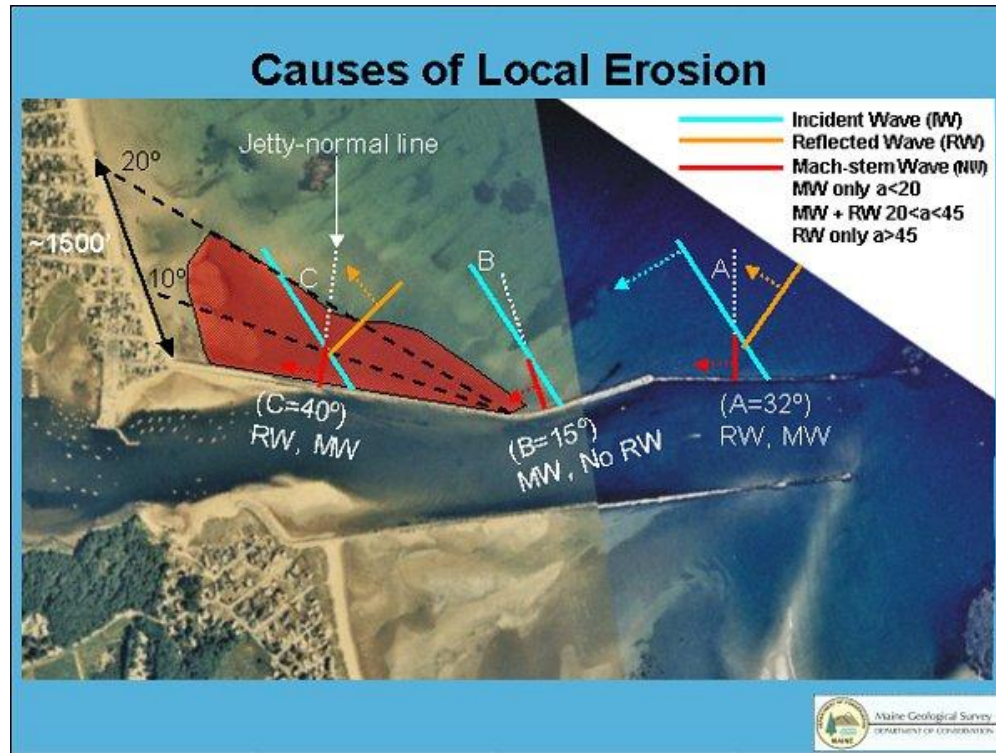
Causes of Erosion

The causes of local erosion at Camp Ellis Beach have to do with a lack of natural sediment supply (cut off from the river), stabilization structures (the beach is heavily seawalled from the jetty northward), and a combination of reflected wave energy and Mach Stem waves (Perroud, 1957). This slide shows the effects of reflected waves and the formation of Mach Stem waves, which travel along the jetty and can build to almost twice the incident wave height. When an incident wave (IW, blue line) approaches from the northeast and strikes the jetty, it forms an angle with the jetty at locations A, B, and C. The angle dictates which type of wave forms;

either a normal reflected wave (RW, orange line), a Mach Stem wave (MW, red line), or both. It appears that both Mach Stem and reflected waves occur on the outer jetty (A), while only a Mach Stem wave is created on the middle section (B). Along the inner section (C), both Mach Stem and reflected waves are created. Mach stem waves can only travel at 10° from their point of origin (dashed line). The trough just north of the inner portion of the jetty is at about 20° from the bend in the jetty, indicating that a combination of reflected and Mach stem wave energy may be responsible for its formation.

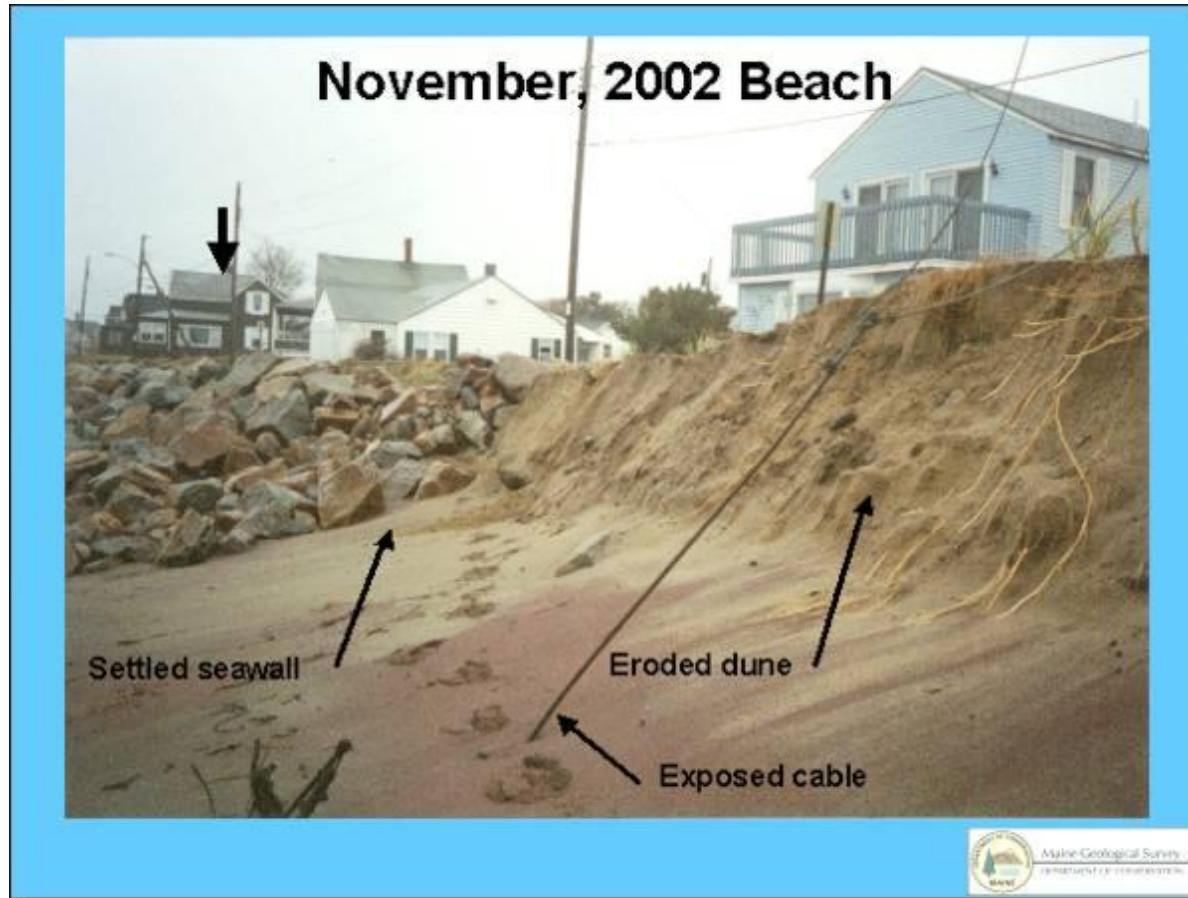
Camp Ellis Beach 2002

Photograph from November, 2002 after a minor northeast storm. Note the eroded dune and settled seawall. The seawall has been extended north since 1987. The large pile of sand was placed by the City of Saco to attempt to mitigate end-erosion occurring at the end of the sea walls.

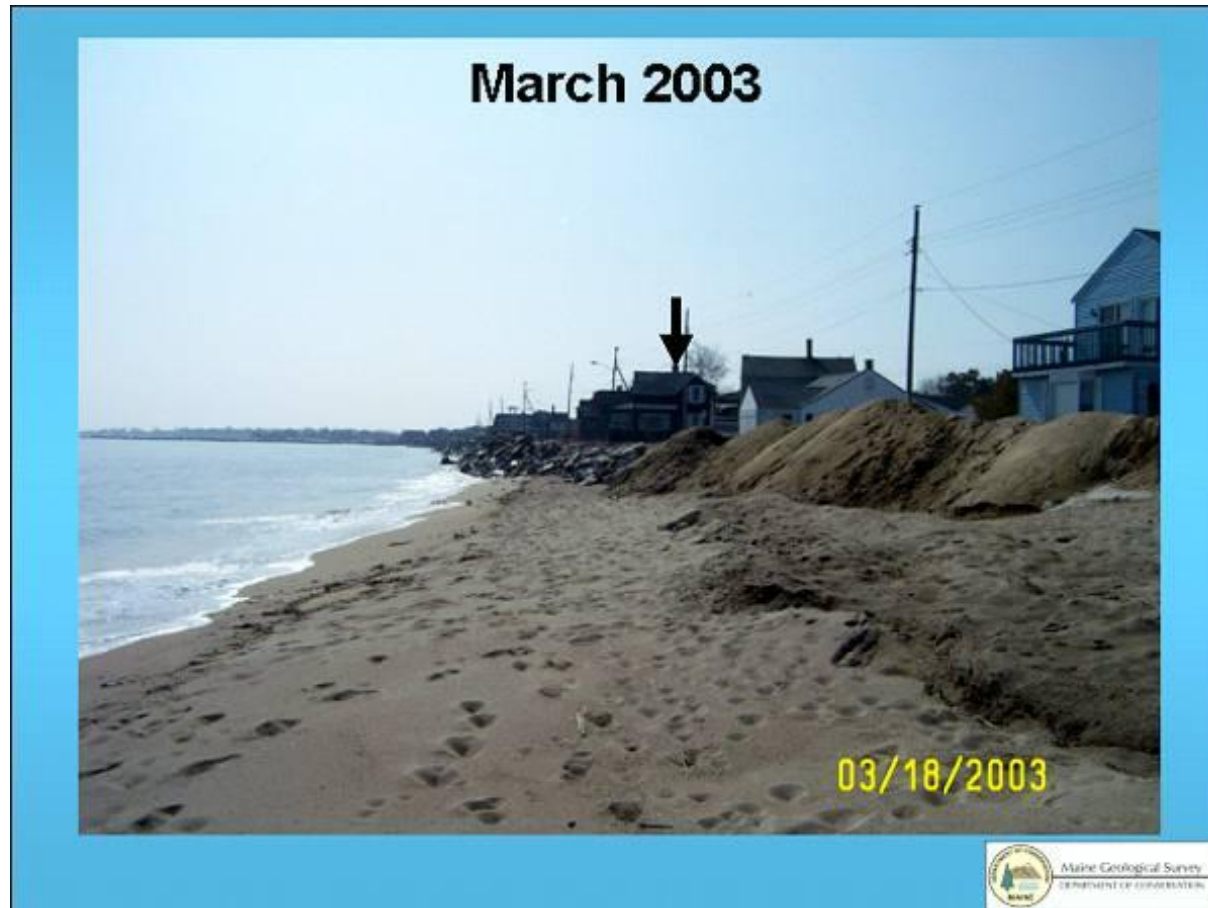
Camp Ellis Beach 2003

Photograph from March 2003 showing the same section of beach and continued efforts to "plug" end-effect erosion at the northern terminus of the seawalls. Compare this slide with the photograph from 1987 (page 26).

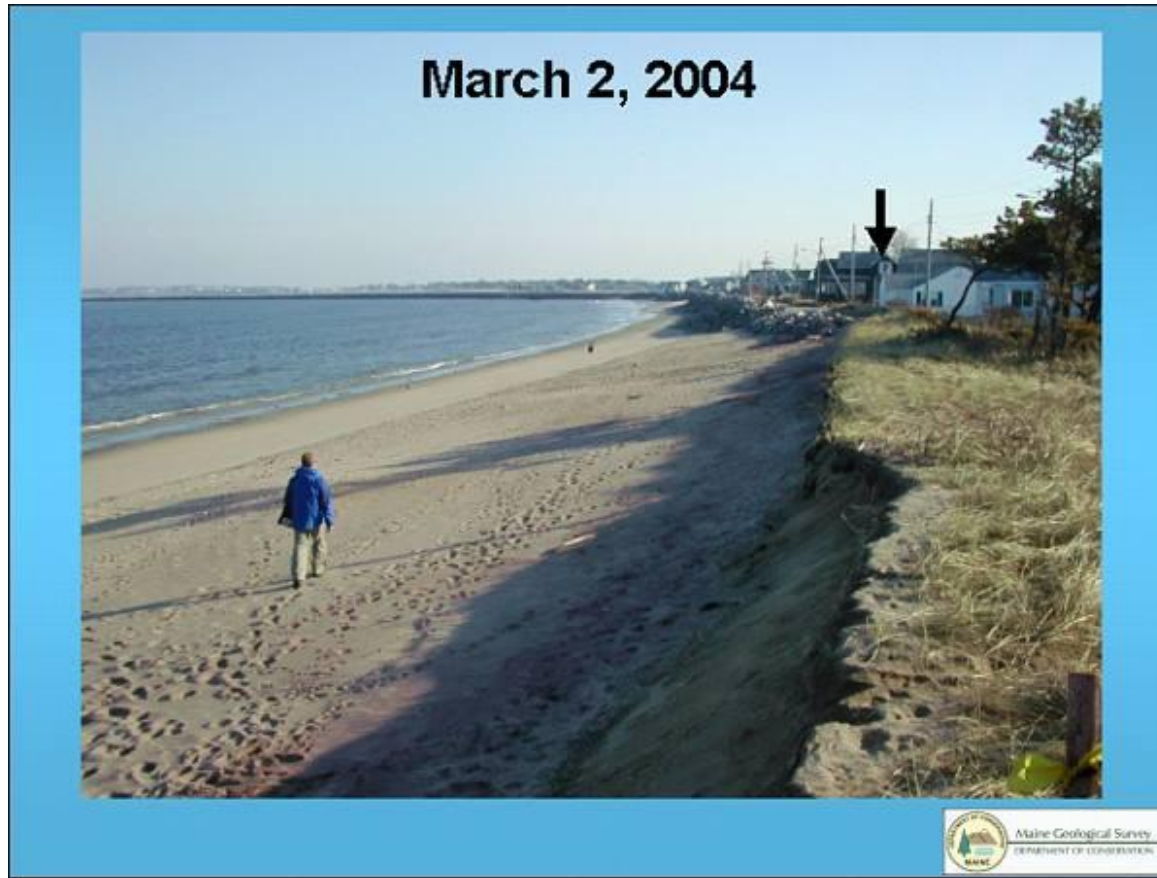
Camp Ellis Beach March 2, 2004

Photograph from March 2, 2004 showing the same section of beach from slightly farther north. Note erosion of dune along the shoreline.

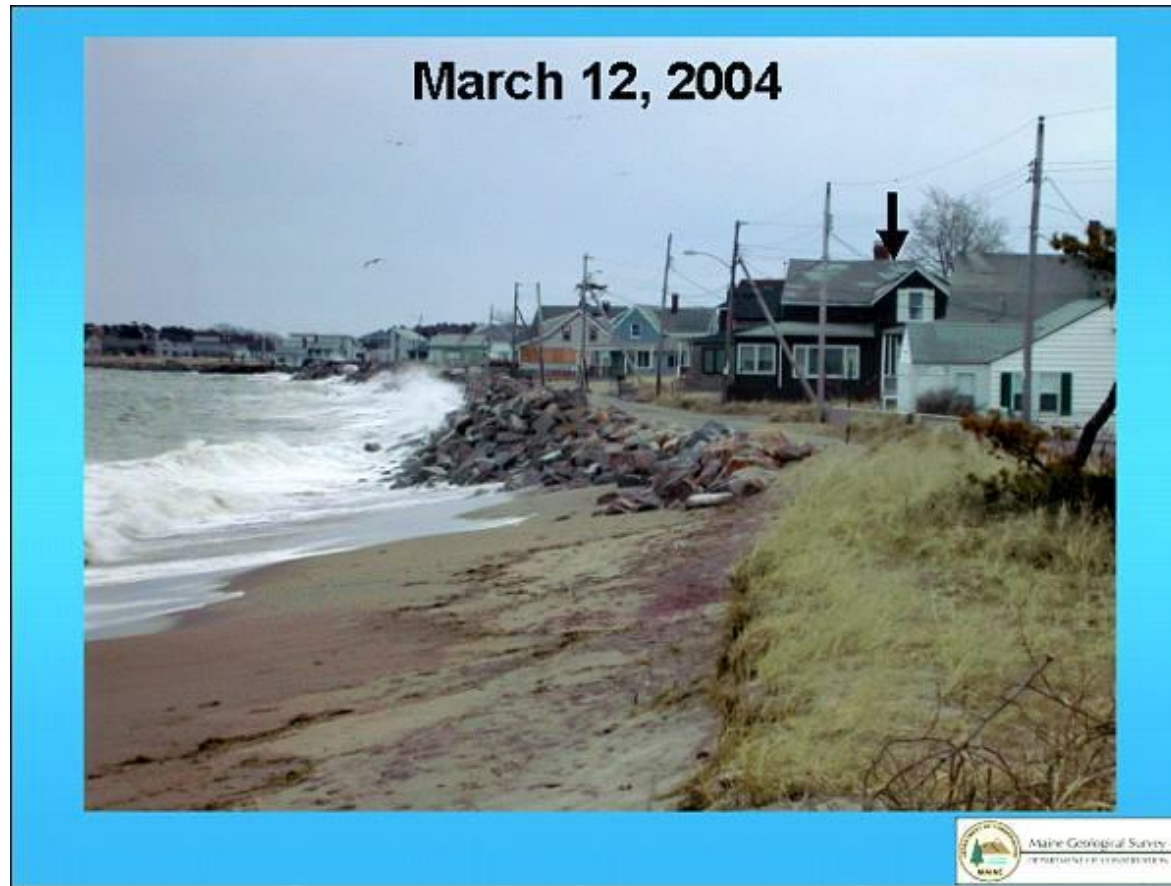
Camp Ellis Beach March 12, 2004

Photograph from March 12, 2004 after a northeast storm. Note full erosion of fill sand at the end of the seawall and seawall settlement.

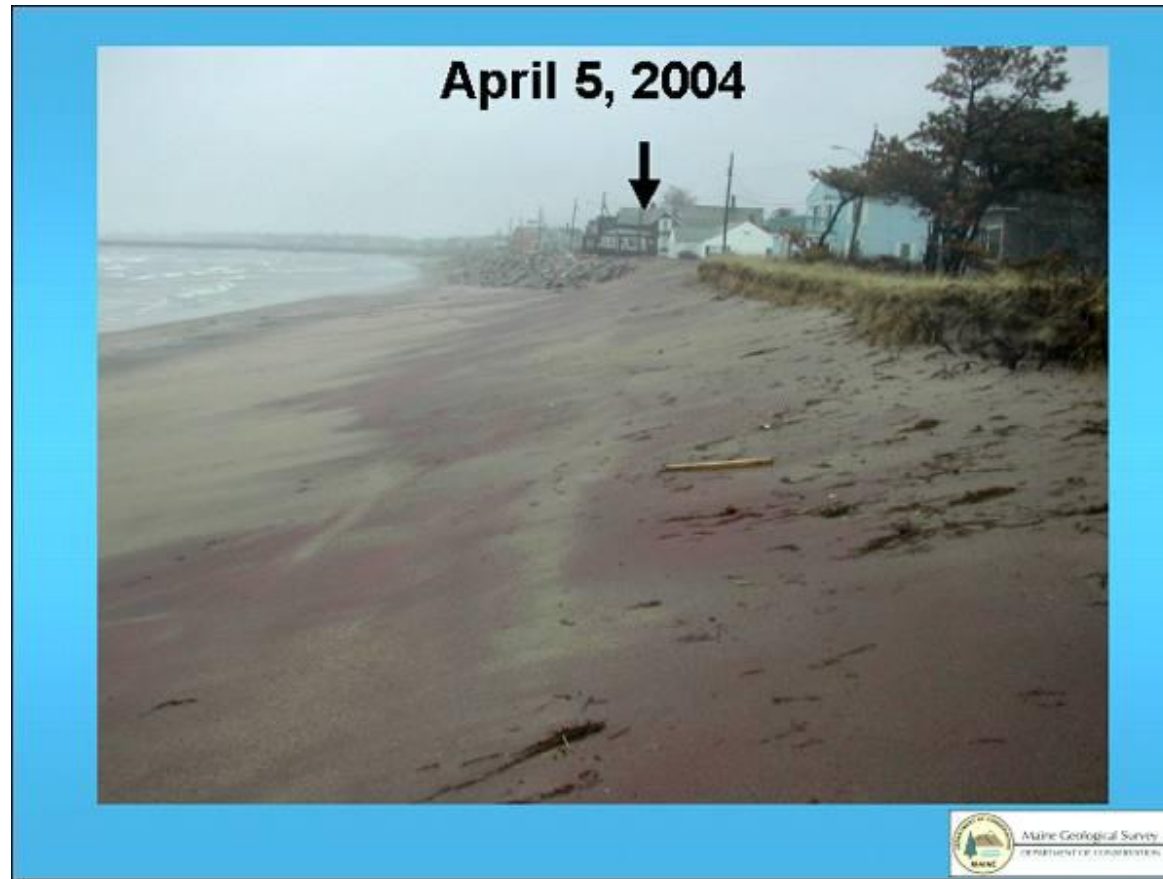
Camp Ellis Beach April 2004

Photograph from April 5, 2004 after a second storm. Note the presence of heavy minerals (pinkish color) that have settled out on the upper portion of the beach. This minor storm actually helped move sand landward on the beach profile.

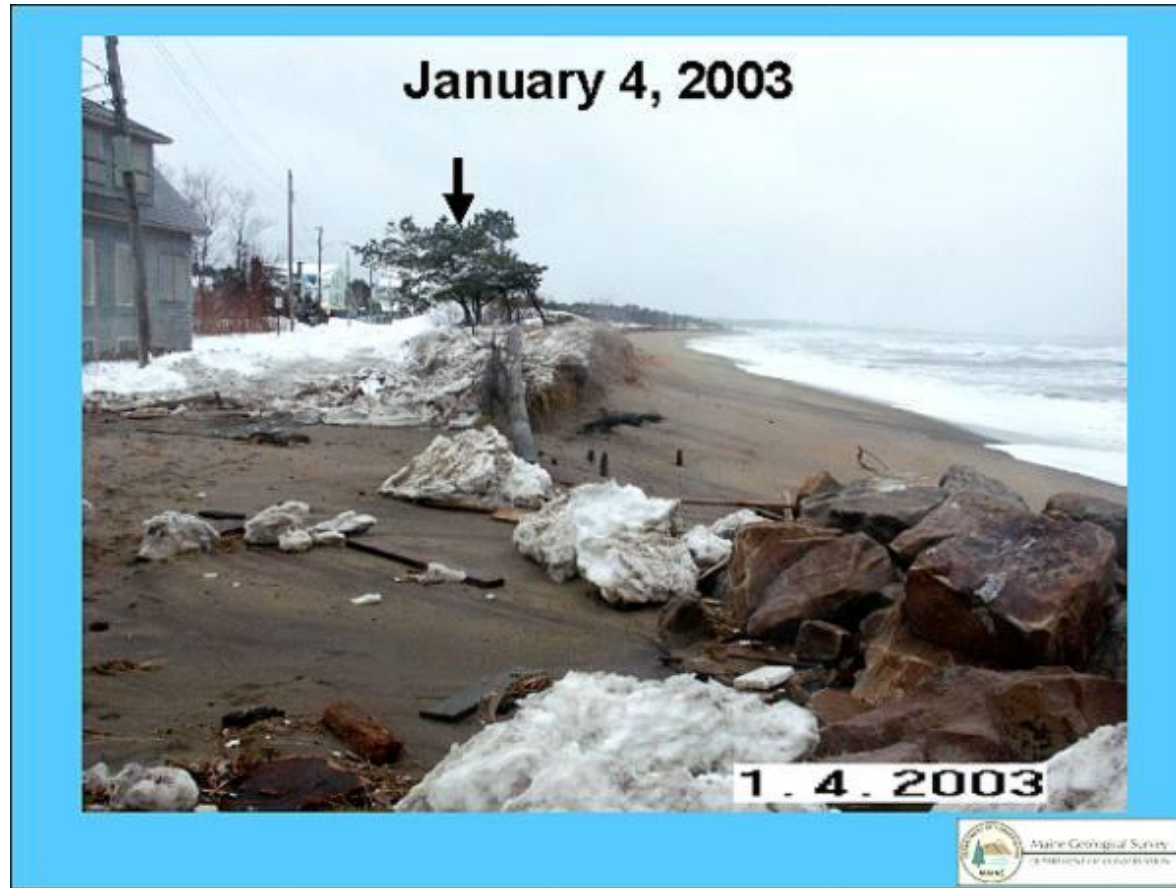
Camp Ellis Seawall January 2003

Photograph during January 2003 northeast storm showing erosion and overwash of the artificial fill area, and erosion of natural dune area north of the seawalls.

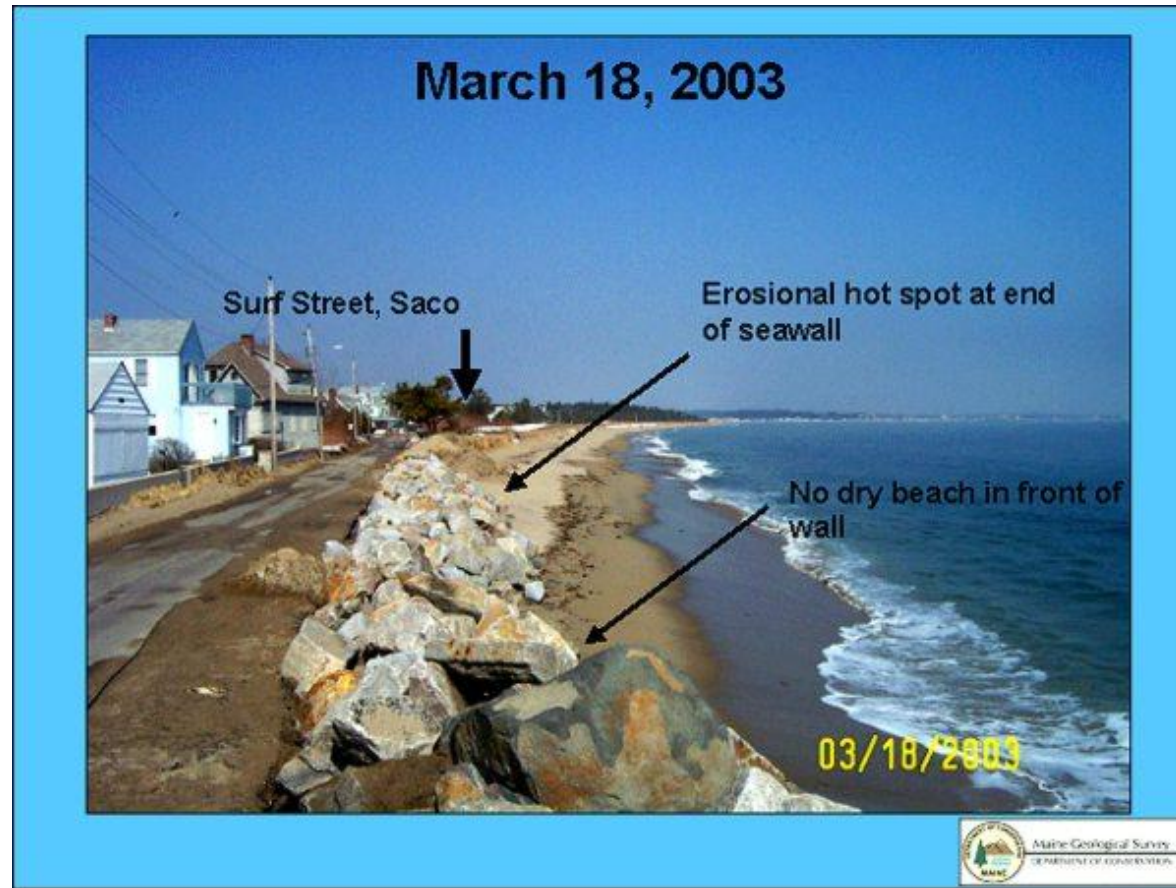
Camp Ellis Seawall March 2003

Photograph from March 2003 showing erosional hot spot at end of seawall.

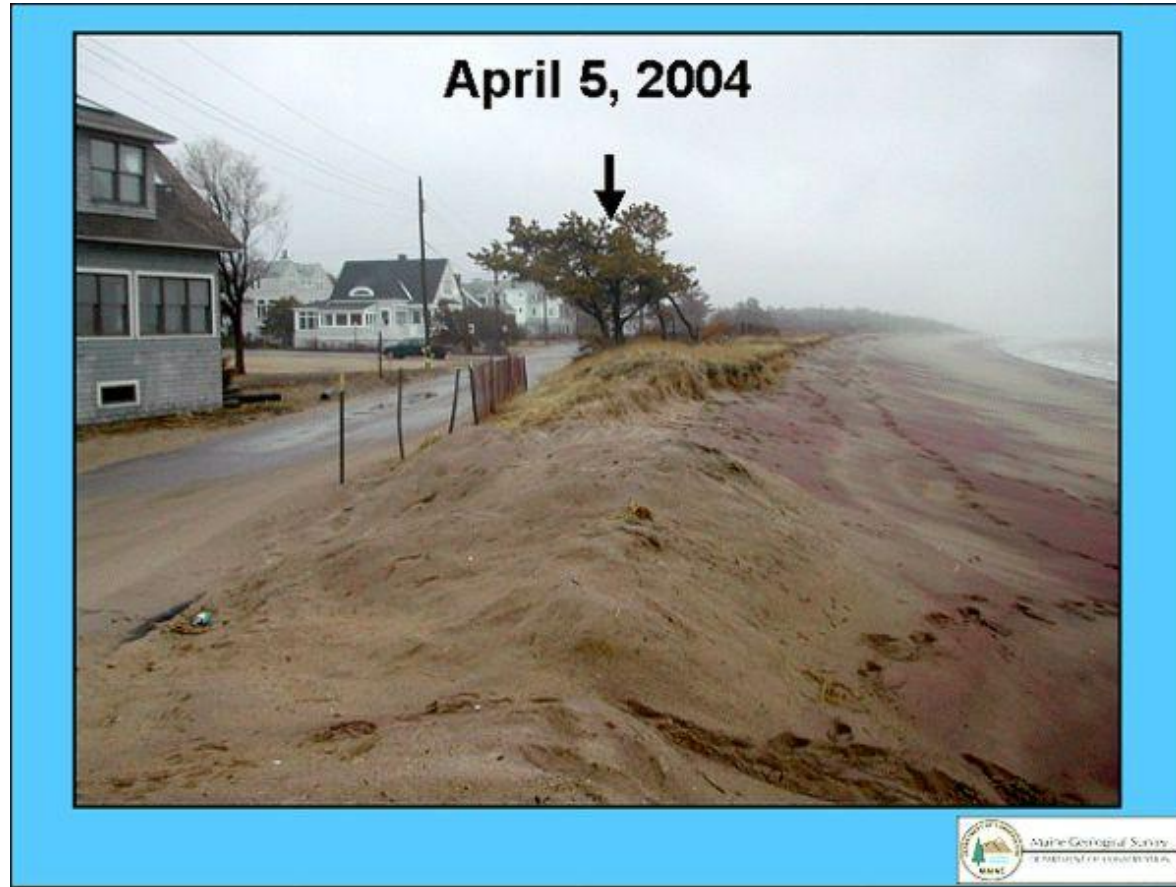
Camp Ellis Seawall April 2004

Photograph from April 5, 2004 showing overwash of fill area onto Surf Street.
